# SERVICE BULLETIN

| <b>Service Bulletin No.</b> | SB-ESCAPE214-216_001 |
| <b>Service Bulletin Affected Parts</b> | Fuse box connector |
| <b>Aircraft type / model</b> | ESCAPE 214 / ESCAPE 216 |

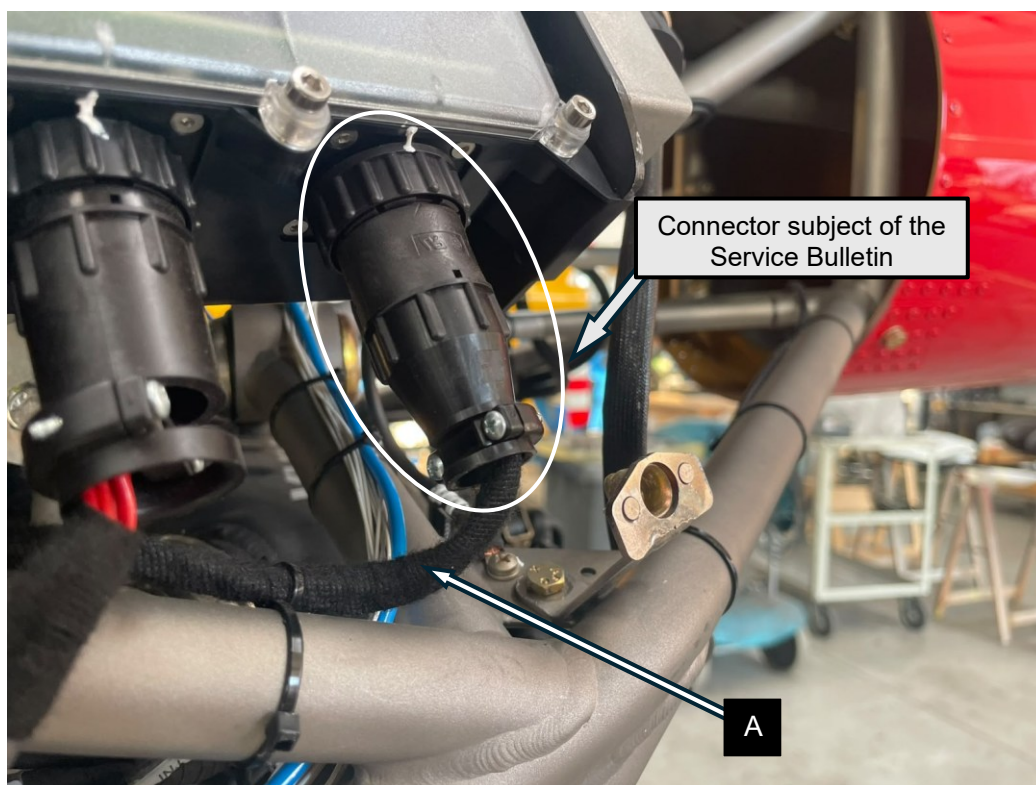
Fig. 1.0 — Protection tape on the wiring.

| Step | Inspection / criterion | Limit / acceptance |
|---|---|---|
| 1 | With the left cowling closed and secured in its flight configuration, check the clearance between the cowling and the fuse-box input connector wiring, highlighted in <b>FIG.1.0</b> . Perform the check using a flashlight, looking from the side or from below the cowling. | Minimum 10 mm. |
| 2 | Inspect the connector wiring insulation for chafing, abrasion or exposed conductors. | No damage. |

| Step | Procedure |
|---|---|
| 1 | If the measured clearance is 10 mm or greater, wrap the first section of the fuse-box input connector wiring with the protective tape supplied by LAMANNA HELICOPTER. The connector concerned is highlighted in <b>FIG.1.0</b> . |
