# SERVICE BULLETIN

| <b>Service Bulletin No.</b> | SB-ESCAPE214_002 |
| <b>Service Bulletin Affected Parts</b> | Tail rotor drive shaft |
| <b>Aircraft type / model</b> | ESCAPE 214 |

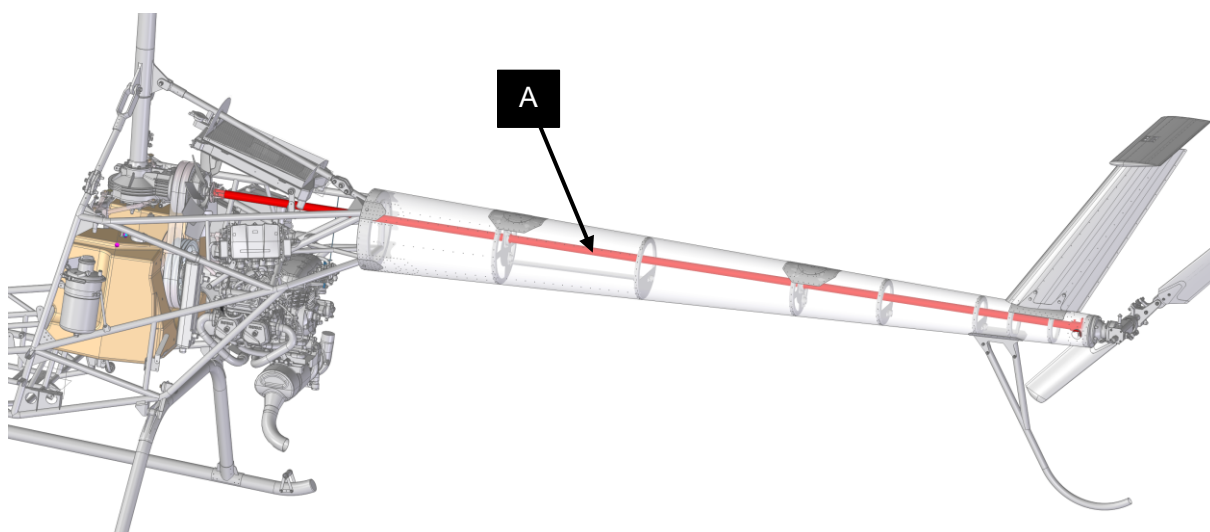
It has been found that the tail rotor drive shaft presents a straightness non-conformity, which generates a cyclic vibration during operation. This vibration prevented tail rotor balancing, as the data read by the accelerometer was distorted. The issue is resolved by replacing the shaft with a component conforming to the standard defined by LAMANNA HELICOPTER.

Fig. 1.0: Tail rotor drive shaft representation in the overall helicopter assembly.

Replacement of the tail rotor drive shaft and perform tail rotor balancing.

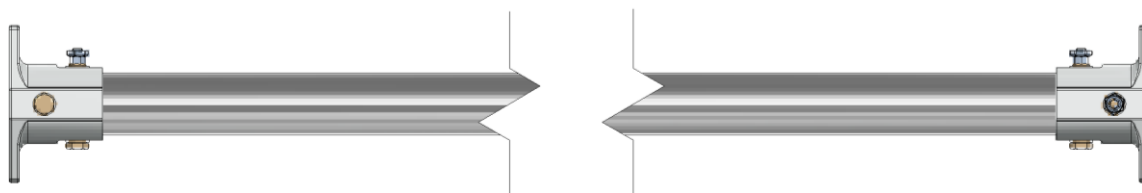
Fig. 2.0: Tail rotor shaft assembly representation.

| Step | Procedure |
|---|---|
| 3 | Disassemble the rear Thomas joint from the drive shaft assembly |

| Step | Procedure |
|---|---|
| 1 | Assemble the rear Thomas joint to the drive shaft assembly |
